Case Study: Improvement of the Maer Lane STW Inlet Works

HUBER Technology recently completed and commissioned a large project for South West Water to improve the inlet works facility at the above site which treats the sewage from the town of Exmouth in Devon.

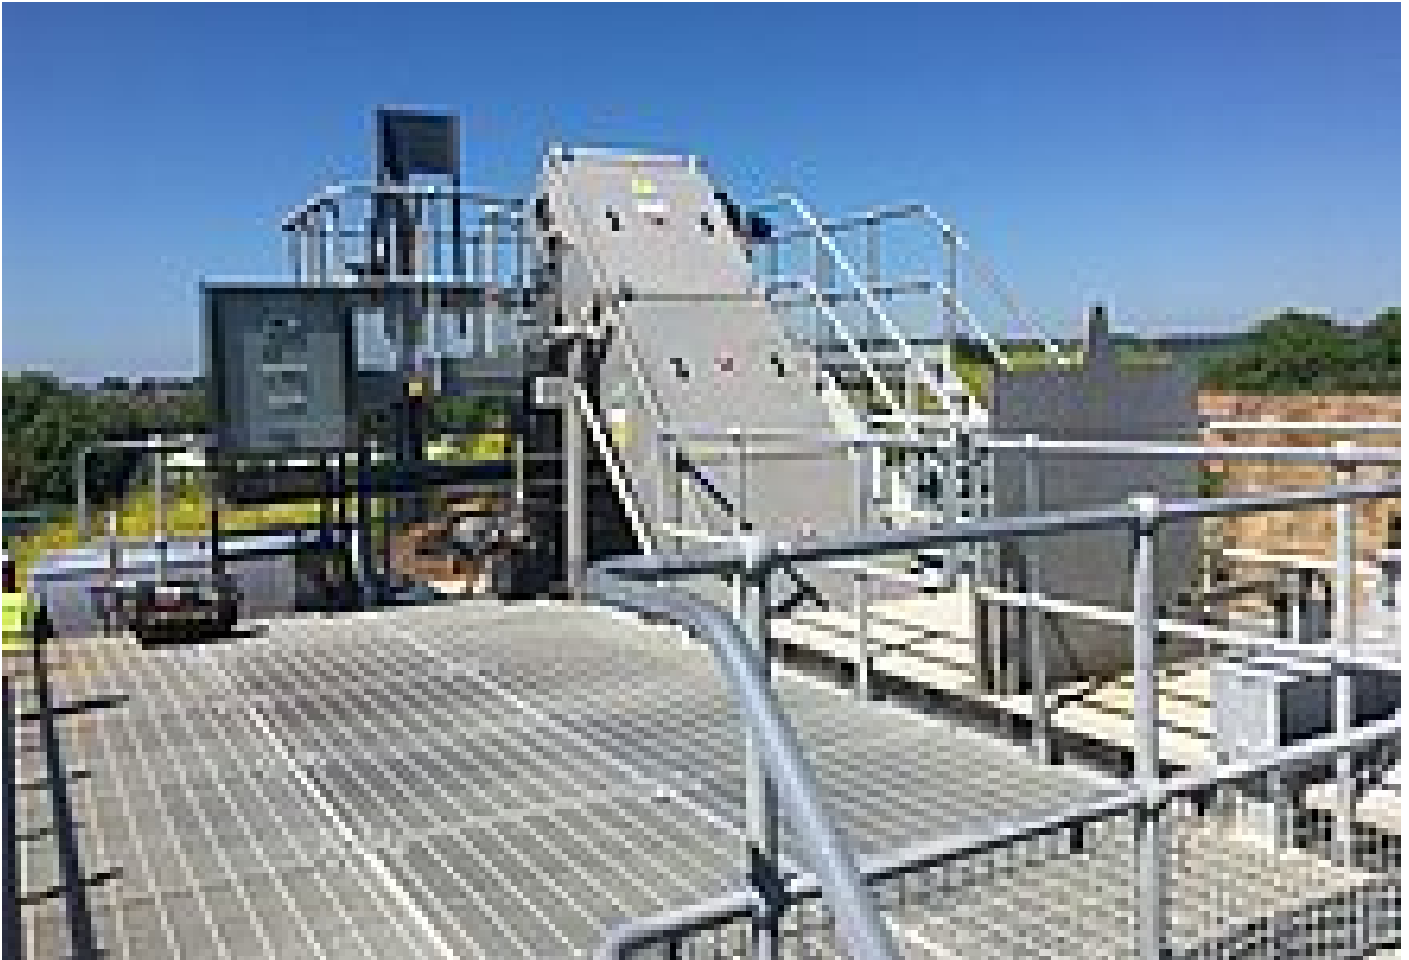
New RakeMax® screen installed on top of the existing balance tank

Previously the flow into the balance tank was via four pumped rising mains, flow to the inlet screens was controlled by penstocks in the balance tank. We worked with the contractors – Tecker to develop a solution to minimise downtime. This solution was to install the coarse screen into a off-site fabricated site channel which could be mounted on top of the existing balance tank structure.

This was installed on site and the rising main connections made, the coarse screen was then installed into it with the screening discharging directly to a skip.

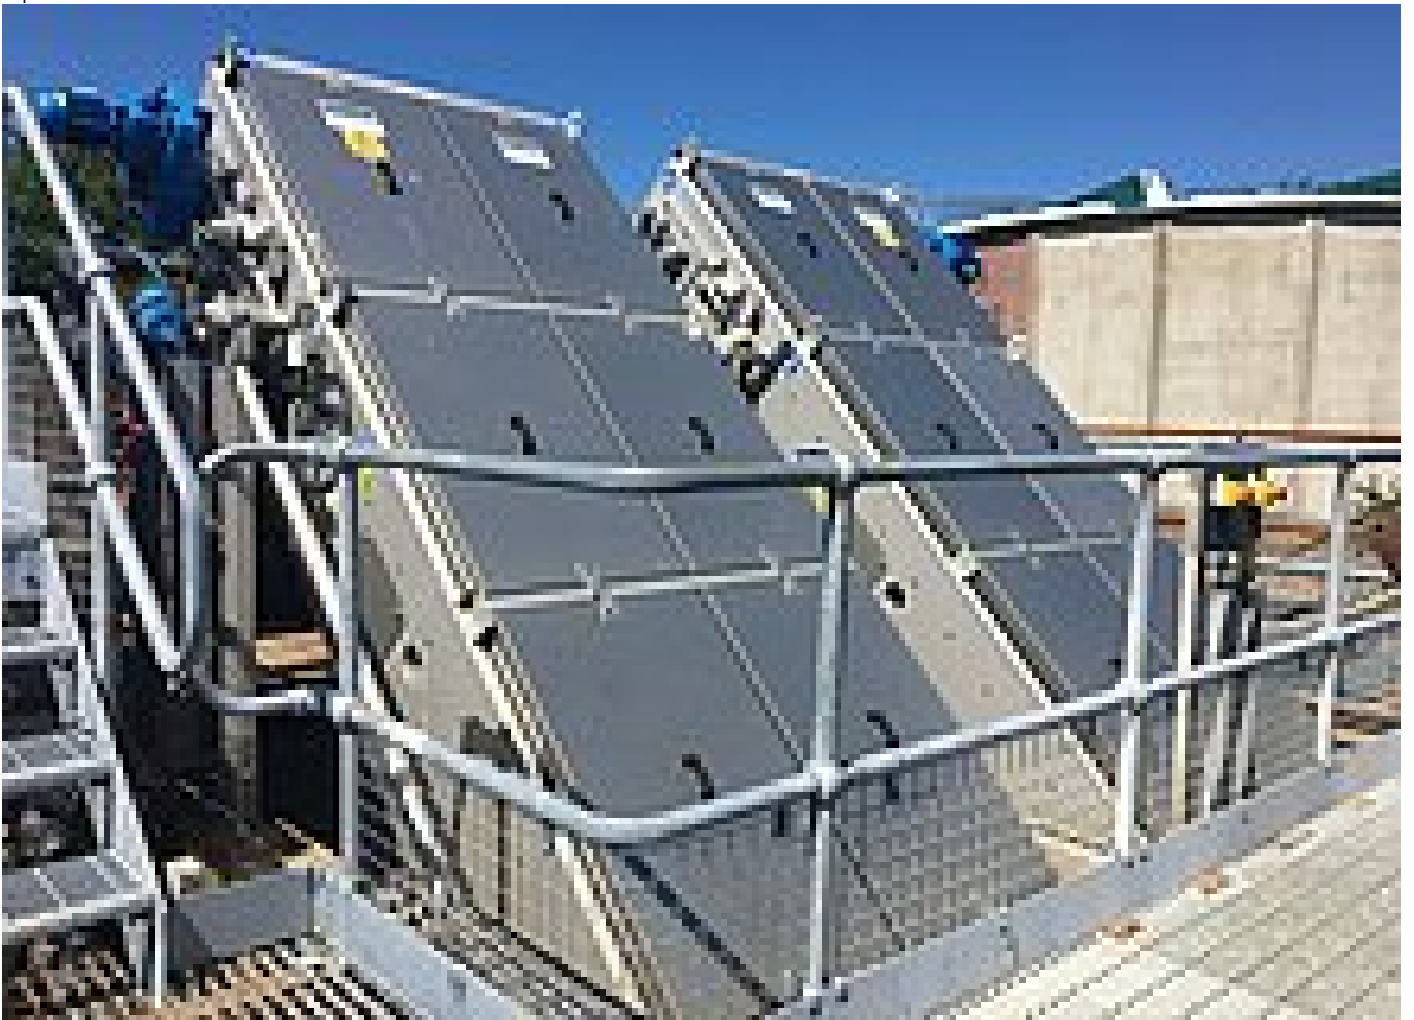
New EscaMax® screens installed at 60 degrees into the existing inlet works

The fine screens and handling plant were installed in a phased manner to allow the screening at the inlet works to be maintained.

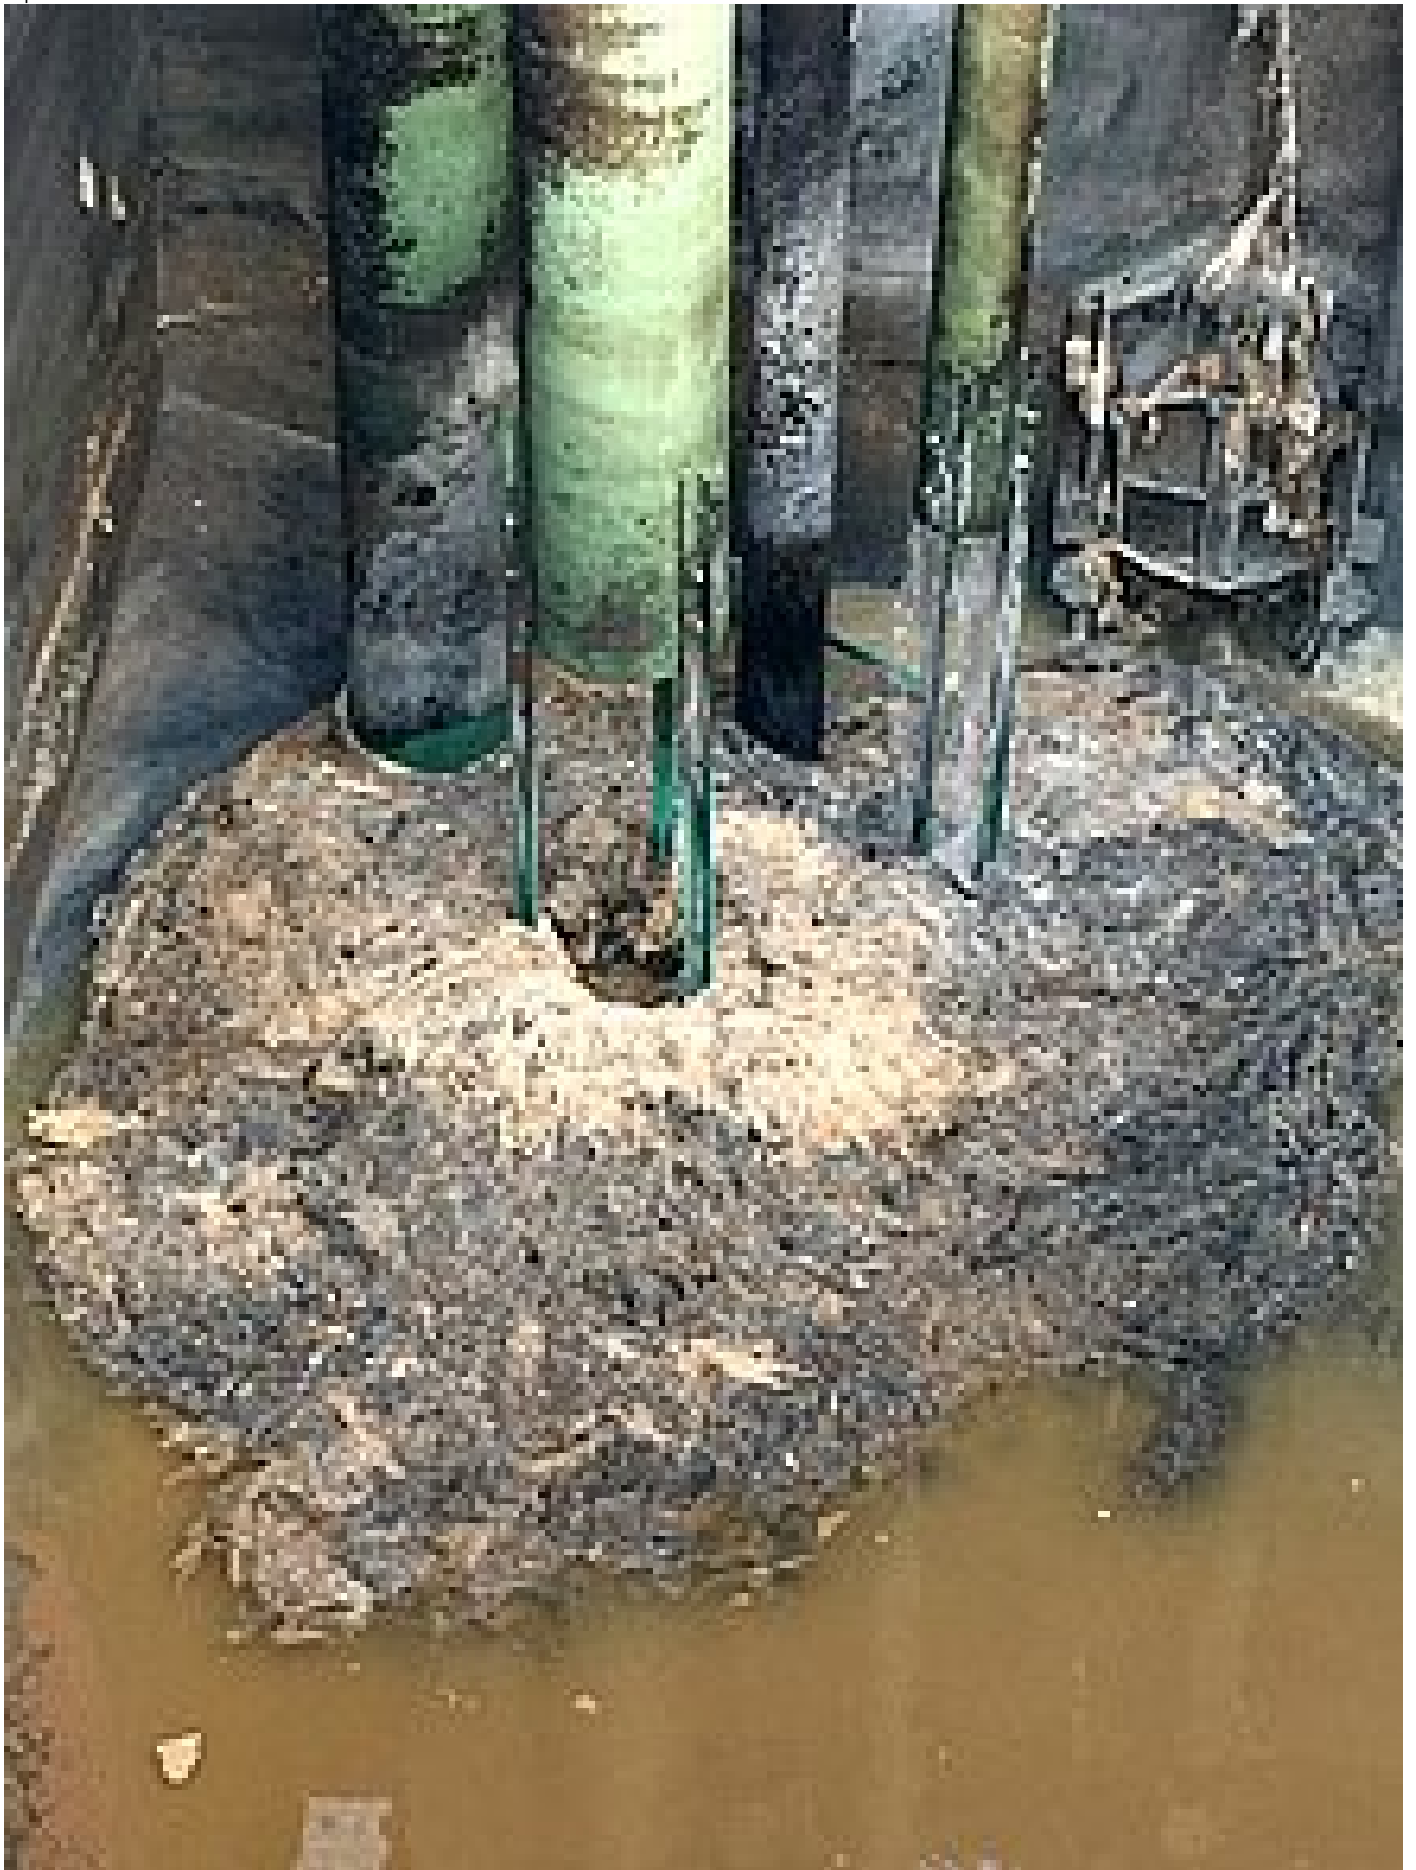
Screenings build up in balance tank – before screens were fitted

HUBER Technology were approached by Tecker towards the end of 2015 to look at improving the existing inlet works on site. The site features a balance tank which was prone to a large build up of rag and screening which were overloading the existing inlet works. Cleaning of this rag build up proved difficult and dangerous so the project was split into two sections, supply of a coarse screen to protect the balance and storm tanks and supply of new fine inlet screens and screenings handling equipment.

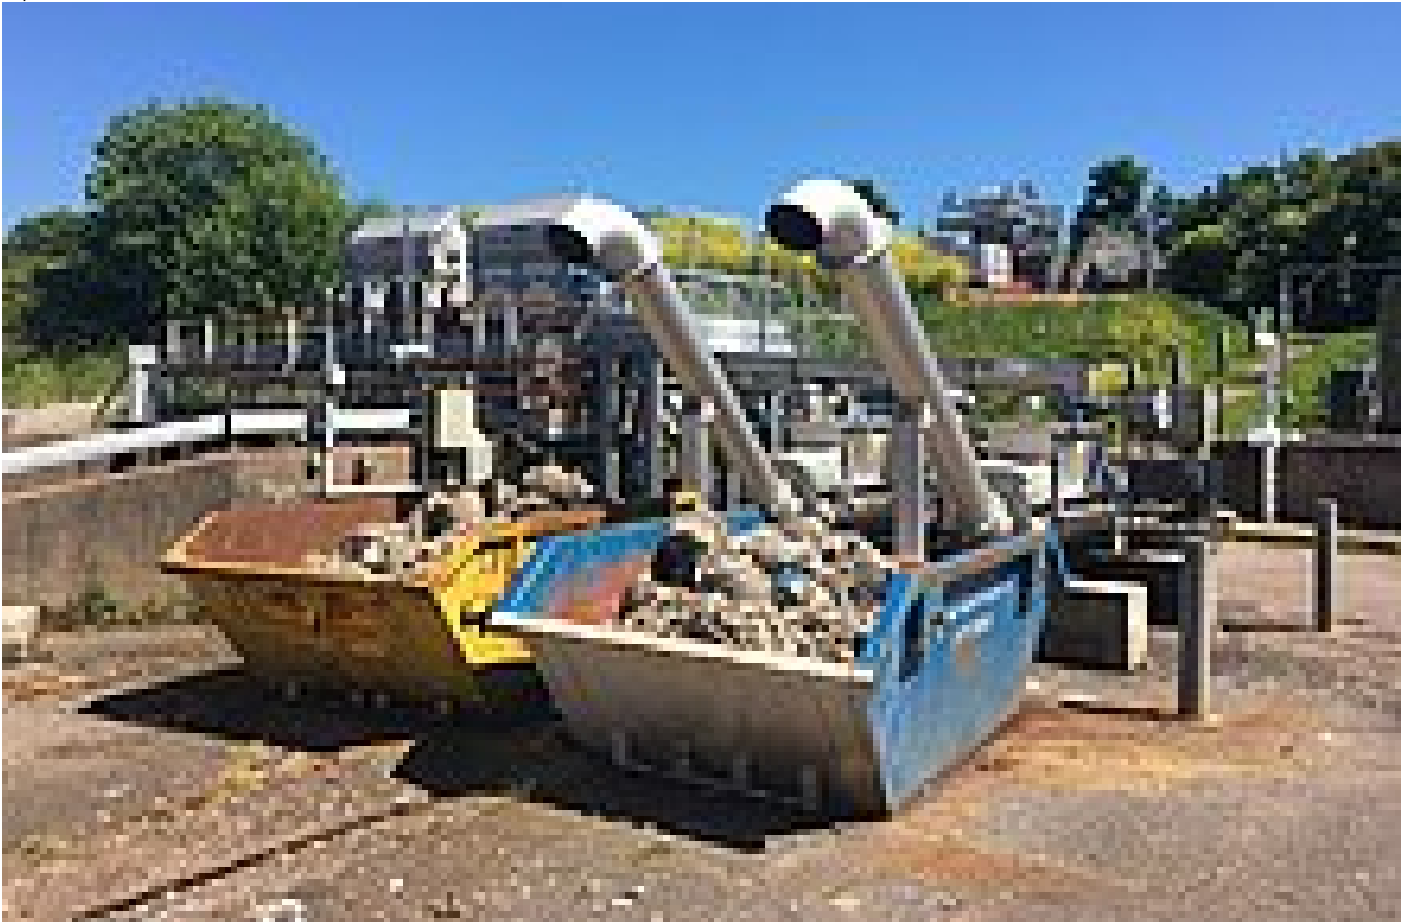
New HUBER Wash Press WAP®-L BG4v screenings handling plant, EscaMax® inlet screens and RakeMax® bar screen in the background

- 1 x HUBER Multi-Rake Bar Screen RakeMax® 4160/990/40, throughput 1027 l/s peak flow per screen
- 2x HUBER Belt Screen EscaMax® 5000/1352/6, throughput 363 l/sec peak flow per screen
- 2 x HUBER Screenings Wash Press WAP® WAP/L BG4-V, throughput 4.5m³/hr
